HC Sinus Slide® joints for lasting repairs in industrial floors

1. HC-Sinus Slide® repairs with jointing system

2. HC-Sinus Slide® repair joint without jointing system

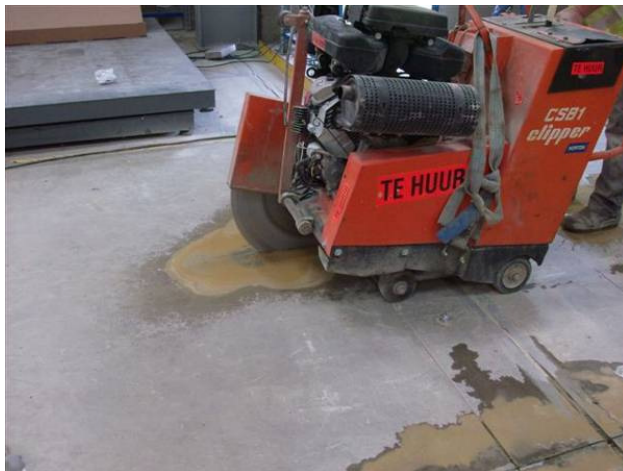
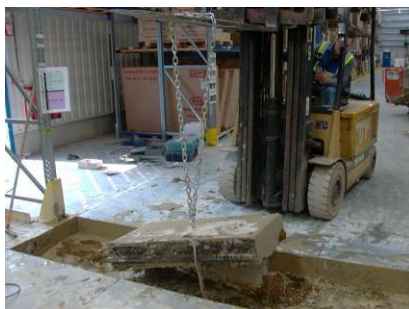
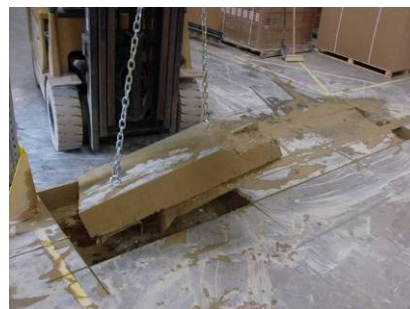
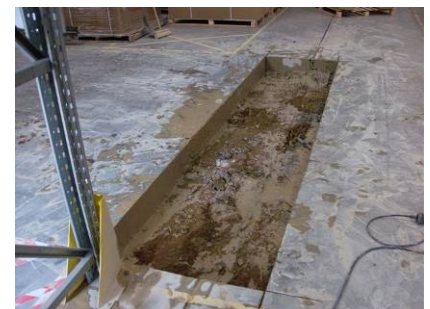
Saw-cut the concrete full depth on both sides of the damaged joint on a width of approximately 800 to 1000 mm. Remove carefully the concrete and re-level and re-compact the sub-base material.

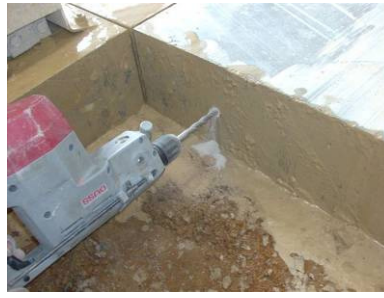
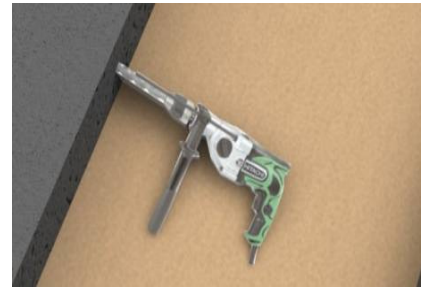
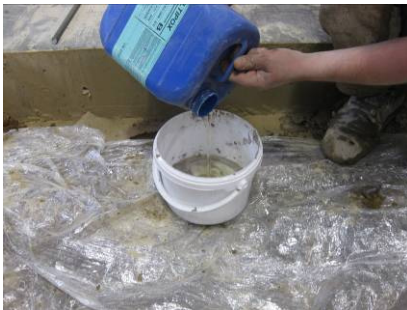
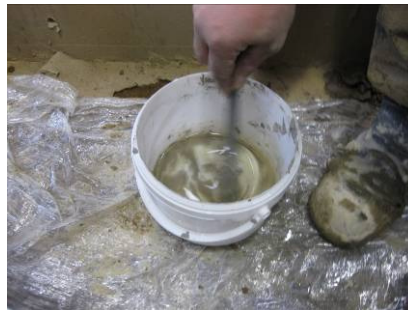
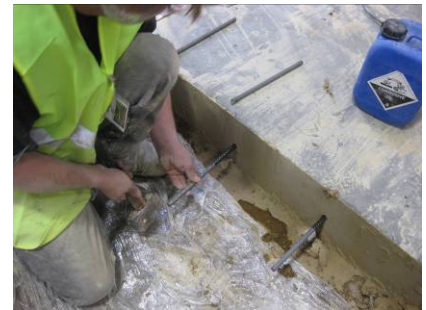
Then drill and fix deformed bars ($\varnothing 16 \times 600$ length) in each concrete slab. At least 3 dowels per meter in each concrete slab. 300 mm of the dowel must be fixed in the concrete (ideally with resin anchorage system) and 300 mm must stick out. Apply special primer on all vertical sides of the concrete slab.

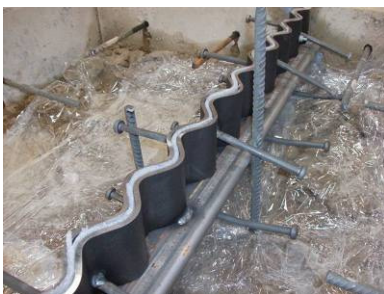
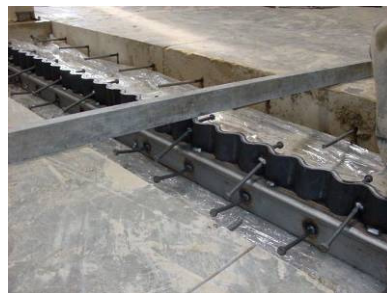
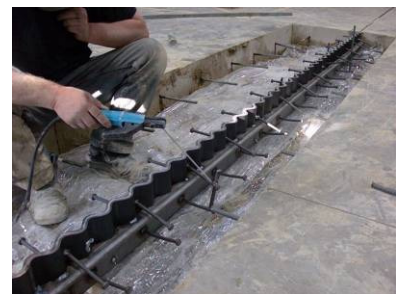
Install a HC Sinus Slide® joint in the middle of the gap opening between the concrete slabs. Level out the HC Sinus Side® joints down and across. Eventually, weld the dowels fixed in the concrete slabs to the anchorage system of the HC Sinus Slide joint or use reinforcing mesh to link dowels and joint connectors.

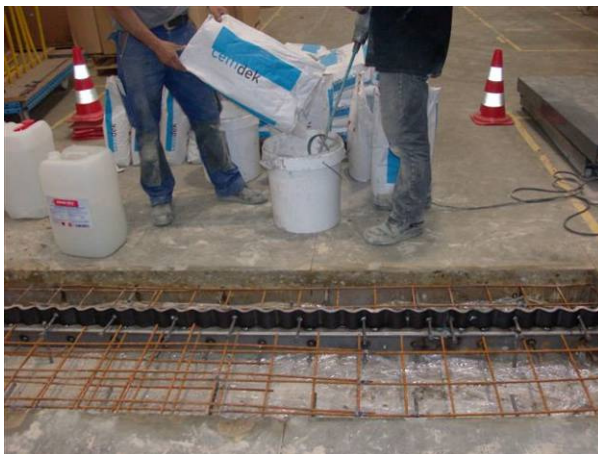
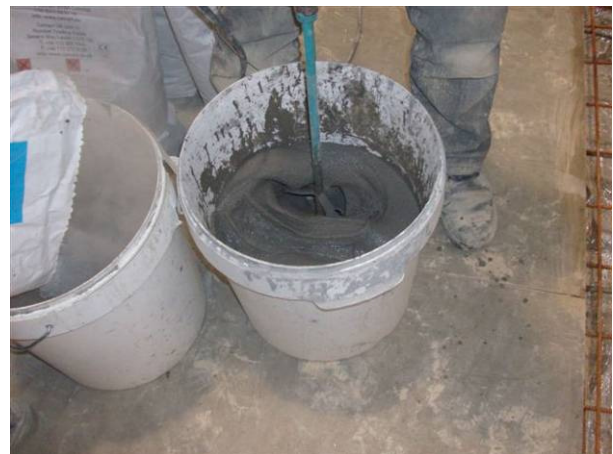
Then fill up the opening gap with (reinforced) concrete or special repair concrete. Finish the floor by polishing. It is recommended to use a HC Sinus Slide® joint with 5 mm foam between the undulated lips to permit a horizontal movement in the two directions in case of extreme fluctuating temperatures. This repaired jointing system with sliding capacity will realise optimal smooth load transfers by 100% shock- and even vibration free wheel crossings. Future damage is almost impossible and unprecedented comfort is achieved. Yearly savings on forklifts wheels maintenance or replacement are substantial.
